The Rover P5 Club
www.roverp5club.org.uk

Buyers Guide

Rover produced two main P5 types; the 3 Litre Straight Six, known as a P5 and the 3.5 Litre V8 known as the P5B.

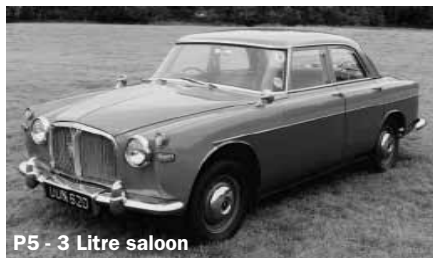
P5 - 3 Litre saloon

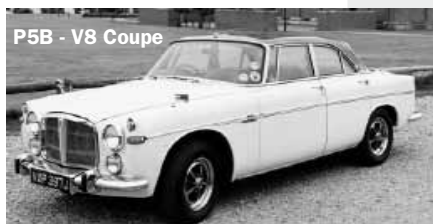
P5B - V8 Coupe
